# Reedy Lake Groundwater and Ecology Investigation

September 2006

ECOLOGICAL ASSOCIATES REPORT BX003-B

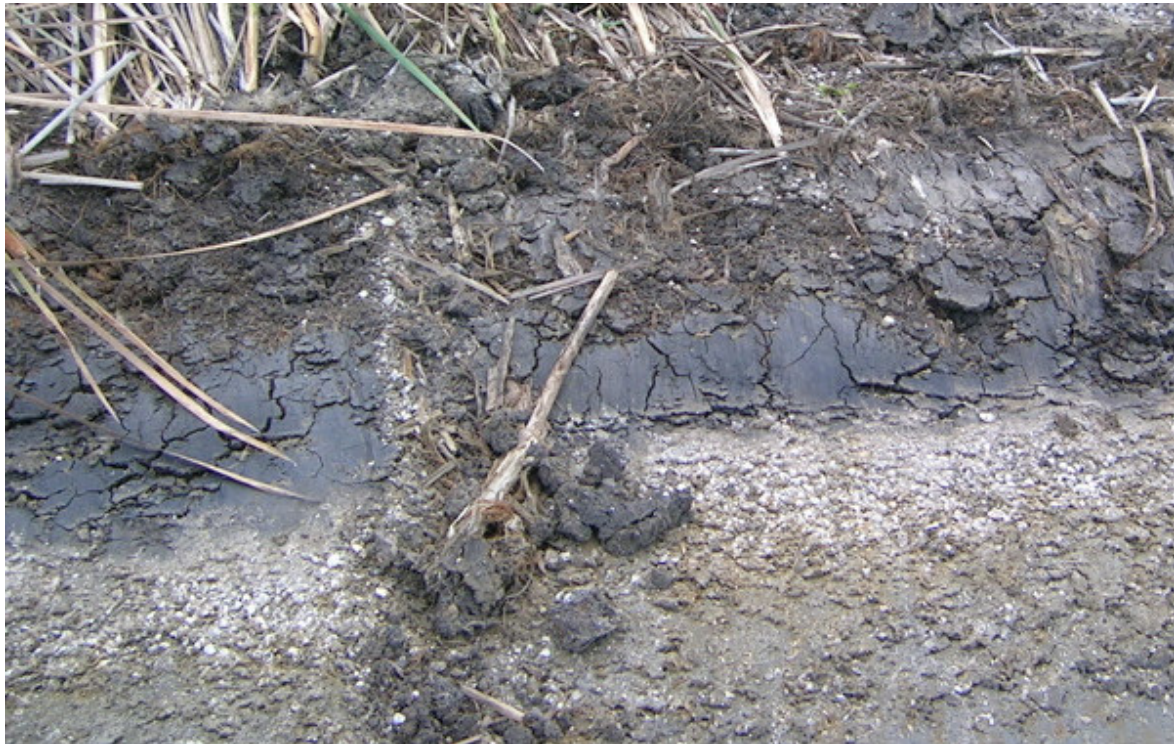
**Figure 1.** *Typha* roots and rhizomes exposed by the excavations for the outlet channel. The surface layer of black silt is approximately 0.3 m thick.

Excavations in the dry lake bed exposed the roots and rhizomes of *Phragmites* and *Typha*. Near the outlet channel roots appeared to only penetrate the shallow silt sediments, to a depth of approximately 0.3 m (Figure 1.). Near the inlet channel, roots appeared to penetrate depths of more than 1.0 m (Figure 2).

Growth is likely to be supported primarily by low-salinity surface water and shallow soil water, rather than saline deep soil water. Both species can produce aquatic roots that access water and nutrients from the water column and avoid toxic salinities in the soil. Furthermore, flooding will apply pressure to the aquifer, possibly reducing the salinity of soil water near the surface. Where earthworks for the inlet and outlet channels had exposed the root system, they appeared to only penetrate the upper silt layer, to a depth of less than 0.3 m (Figure 1).

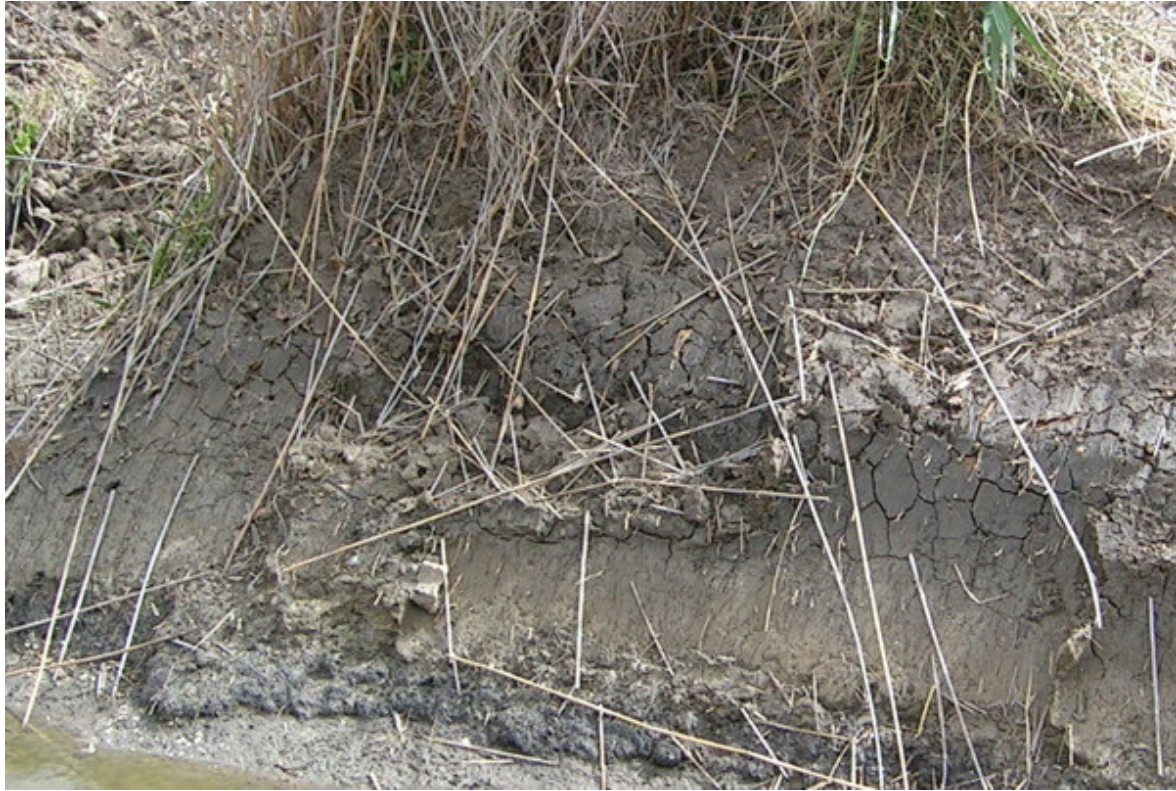
**Figure 2.** *Phragmites* roots and rhizomes exposed by excavations for the inlet channel. The channel is approximately 1 m deep.

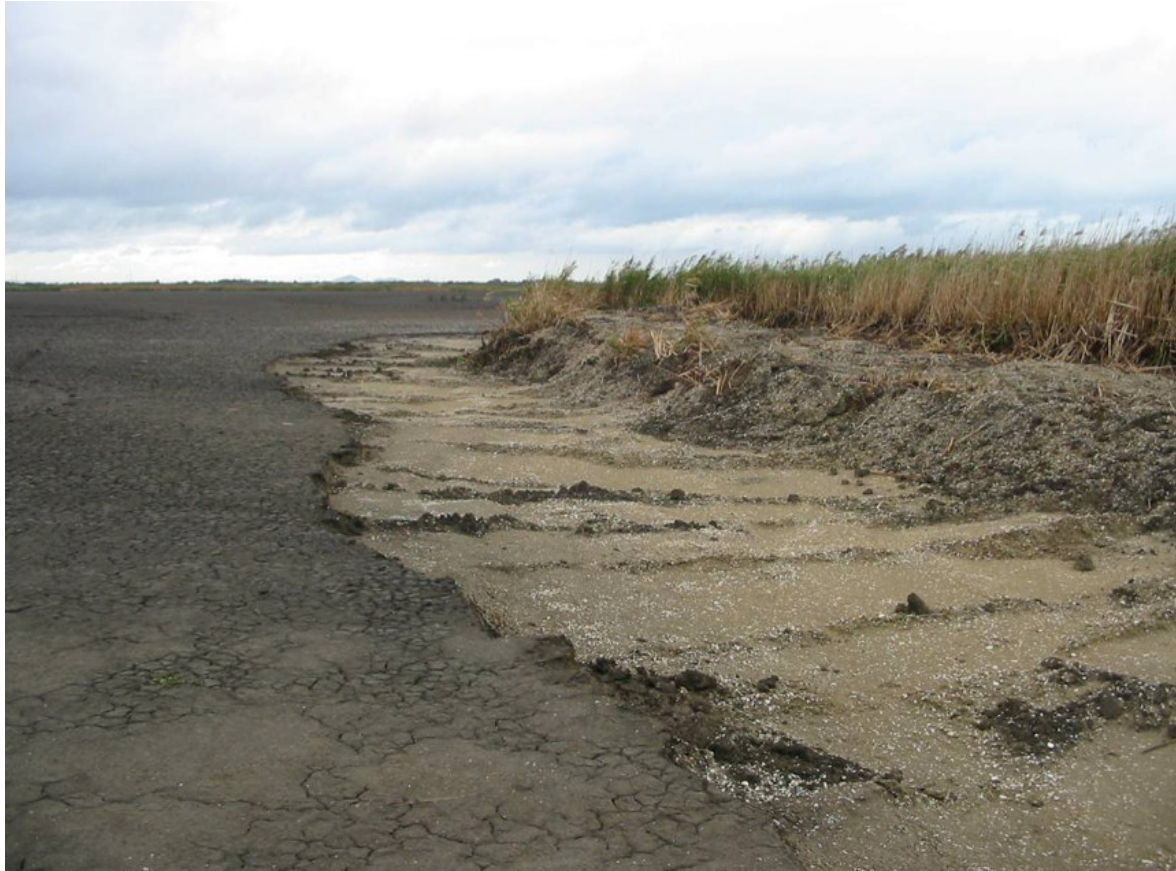
**Figure 8. Excavations of the Reedy Lake bed showing the shallow surface silt and underlying shelly sands – from Miner (2006).**

The lake bed comprises a veneer of silt 0.1 to 0.2 m thick (Figure 8). This is underlain by a bed of sands and shells, generally 1 to 2 m thick. Siltier sediments lie below these sands to a depth of 4 to 6 m. Below this lies a layer of highly plastic clay, more than 4 m thick.
